AIRCRAFT CORROSION – REVIEW OF CORROSION PROCESSES AND ITS EFFECTS IN SELECTED CASES

Magdalena Czaban

Institute of Aviation, Warsaw, Poland

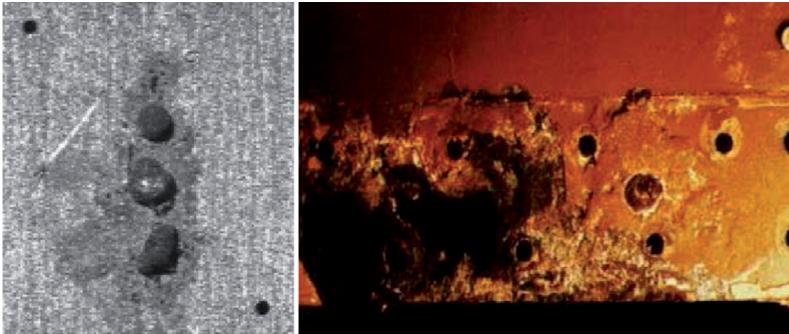
Fig. 1. Corrosion pits on the surface [19]

Pitting corrosion manifests itself in the form of holes in the structure. Although it can be caused by a number of factors, in most cases it is formed in the presence of chloride ions (Cl^-) in electrolyte environment in direct contact with the material. Corrosion pits may differ in shapes but they usually develop and

grow vertically and deep into the material. Pits may also initiate the mechanism of formation of extensive fatigue cracks resulting in material strength decrease [16]. The influence of pitting on the fatigue of a structure is currently not fully-known [16]. Many research studies have focused on analysing the possible influence of pitting corrosion on fatigue cracks propagation in aluminium alloys [16, 17, 18].

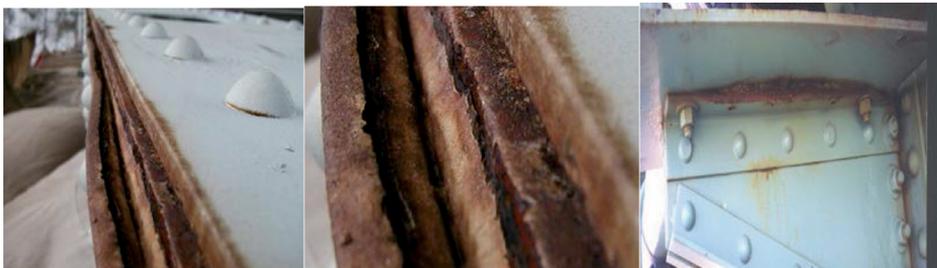
Fig. 2. Crevice corrosion on steel elements [21]

Crevice corrosion is usually localized in crevices or gaps in the surface or places where local stagnation of condensates may occur and the circulation of electrolytes is hindered. The presence of electrolytes in the space between two parts makes it possible to connect them by conductivity [20]. Crevice corrosion can be very destructive and can occur in materials that by definition have very good corrosion resistance, and in hidden places. Crevice corrosion may lead to sudden damage. The discontinuities of the structure where crevice corrosion is usually located are typically geometric elements whose shape results from the structure. These can be, for example: rivets, welds, joints; contact places between a metal and a non-metal, such as composites, glass, rubber; impurities or unremoved corrosion products forming sediments on the surface.

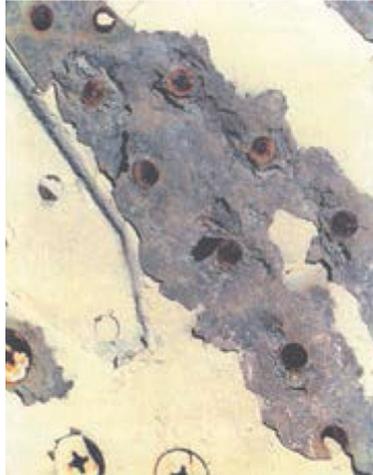
Fig. 3. Galvanic corrosion between magnesium surface and steel connections [22]

Galvanic corrosion occurs when there is a connection of two dissimilar metals in the system. Metals with a lower potential will act as an anode (giving its ions to the system) while metals with higher electrochemical potential will be cathodes.

An example of corrosion caused by a difference in electrochemical potential between the elements of a system is shown in (Fig. 3).

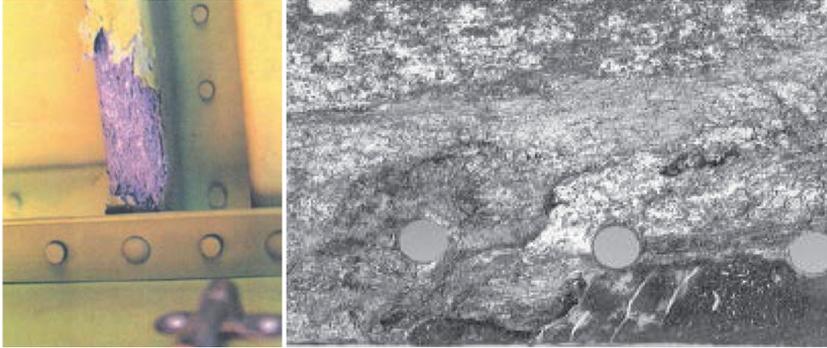
Fig. 4. Exfoliation corrosion [22] [23]

Exfoliation corrosion occurs along the longitudinal grain boundaries in the direction of rolling. When it occurs, exfoliation corrosion may cause a separation of grains in the metal grain layers. It has a layered character. It can be formed in unharmed grain ends, e.g. fixing holes and board edges (Fig. 4).

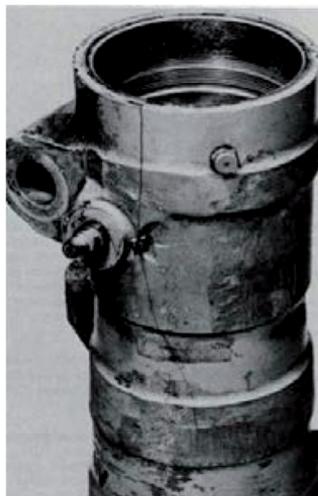
Fig. 5. Crack resulting from undetected stress corrosion [19]

The crack growth mechanism involves simultaneous interaction of the static tensile stress, corrosive environment and metallurgical factors, primarily the chemical composition and the alloy structure. SCC often develops from the pitting or crevice corrosion. Stress levels at which this type of cracking occurs are characterized by significantly lower values than those causing the cracking of parts made of the same type of material.

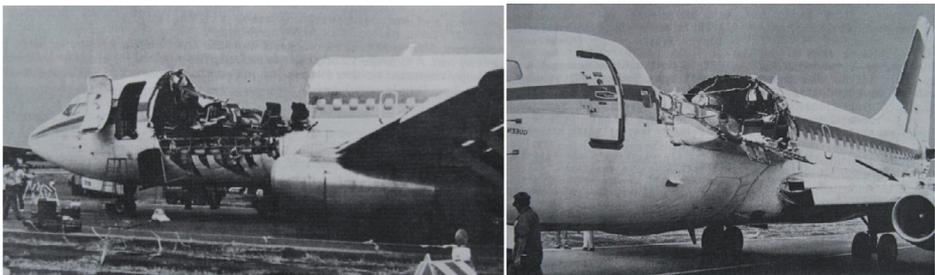
Fig. 7. Boeing 737 from Aloha Airlines after the accident [33]

After levelling off the flight of Boeing 737 to 24000 ft. (8000m) cruising altitude, the pilots in the cabin heard a whooshing sound from the fuselage followed by a windy noise. The captain of the plane observed that “*there was blue sky where the first class ceiling had been*” [31]. In fact a large segment of the upper part of the fuselage was torn off from the plane which created a large hole in the passenger cabin [32]. A major part of the upper crown skin of section 43 was separated during the flight. This caused an explosive decompression in the cabin. The pilot immediately took control of the plane [31]. The first officer reported the emergency to the air traffic controller in Honolulu and informed the Maui airport traffic control about an emergency landing [31]. The pilot managed to land on the island of Maui [15]. This catastrophic accident resulted in the death of one person - a flight attendant who stood in the passing during the separation of the segment from the fuselage [15]. The investigation of the remaining aircraft structure showed multiple fatigue cracks in the holes of the upper row of rivets in several fuselage skin lap joints [15]. Because the overlapping panels were provided to remain strongly bonded, the fatigue cracks were not predicted to be a problem likely to cause a structural damage to the aircraft. The inspection in the lap joints of other airplanes showed that the problem was connected with disbonding, corrosion and cracking problems [15]. The “pillowing” phenomenon caused by build-ups of voluminous corrosion products inside the lap joints led to a separation of the faying surfaces [15].

The airplane was a 19-year-old Boeing 737 [15], manufactured in 1969 and delivered to the Aloha Airlines in the same year. The Aloha Airlines had eleven Boeings 737, all with flight cycles of 60000 or more [31]. This specific jet had accumulated 35496 flight hours and 89680 flight cycles [31]. The airlines were not aware of the effect of the flight cycle accumulation [31]. In fact, the maintenance record showed that corrosion was detected by personnel providing the maintenance but there were no corrective actions undertaken that should have followed that discovery. The team accepted the signs of the ongoing corrosion as a normal operating condition [34], [31]. At that time, the corrosion prevention and control programs (CPCP) were not available for an entire plane. The Aloha Airline accident was the initiator of the recommendations to develop a model for CPCP that would be a part of every operator's maintenance programs [34]. It is visible how important the plane use rate is. An intensified exploration under demanding conditions in a wide range can decide about the occurrence of possible corrosion failures. This aspect should be taken into account when carrying out research aimed at prolonging the service life.

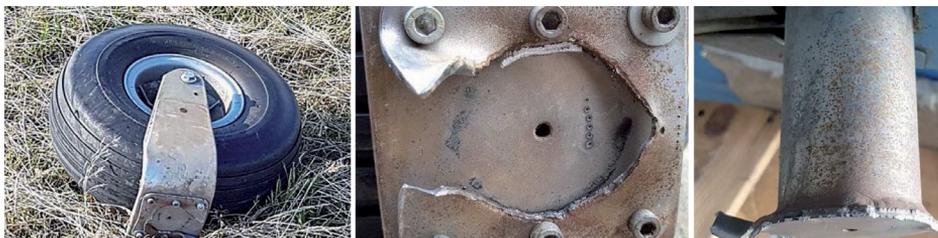
Fig. 8. The separation of wheel from the landing gear [35]

The incident happened while performing the check flight after the engine repair [35]. During the run-up just before the takeoff, at the speed of approx. 80 km/h, the wheel from the right landing gear separated from the plane [35]. The separation of the lower tile from the gear took place around the joint connecting these parts [35]. The tile was destroyed (Fig. 8).

From the photographic documentation, it can be seen that a significant part of the weld (over 25% of its length) showed signs of corrosion penetration, which had significantly reduced the strength of the joint and initiated the process of its destruction [35]. Moreover, the authors of the report [35] admitted that the corrosion penetration into the weld could not have been detected during the standard visual inspection as its detection would have required disassembling

parts and the use of an appropriate defectoscopy method. The official cause of the accident was the destruction of the connection between the landing gear and the tile caused by corrosion penetrating the weld resulting from long-term operation time [35]. This incident shows how important it is to select proper detection techniques, adequate to the structure and the information that we want to gather.
