VIBRATION PROPERTIES OF STEEL CONSTRUCTED HOSPITAL ELEVATED HELIPADS

Wiesław Krzymień, Michał Szmidt, Sławomir Cieślak

Łukasiewicz Research Network – Institute of Aviation, Al. Krakowska 110/114, 02-256 Warsaw

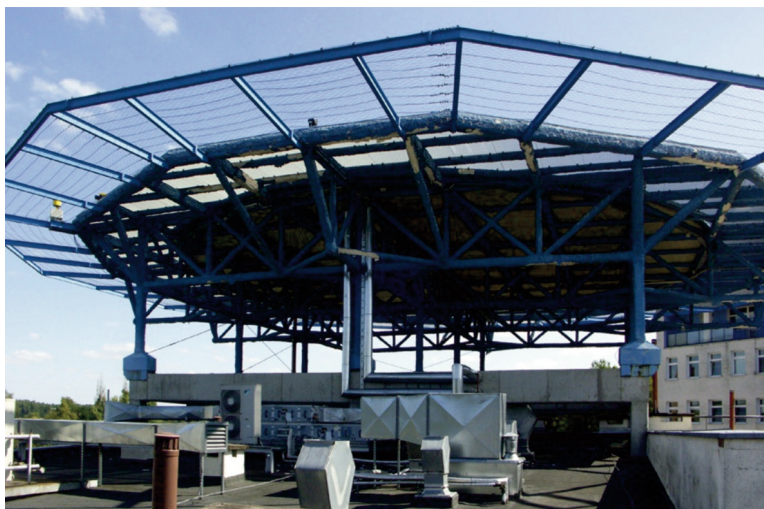
Fig. 2. Part of the steel construction of the helipad in the MSWiA hospital in Olsztyn.

Steel helipads are usually of a lighter truss structure (Fig. 2) mounted on dozens of steel pillars with the plate made of duralumin or composite panels containing the heating and drainage systems and the pillars which are placed on vibroinsulators. This solution is used in case of older (i.e. existing) buildings.

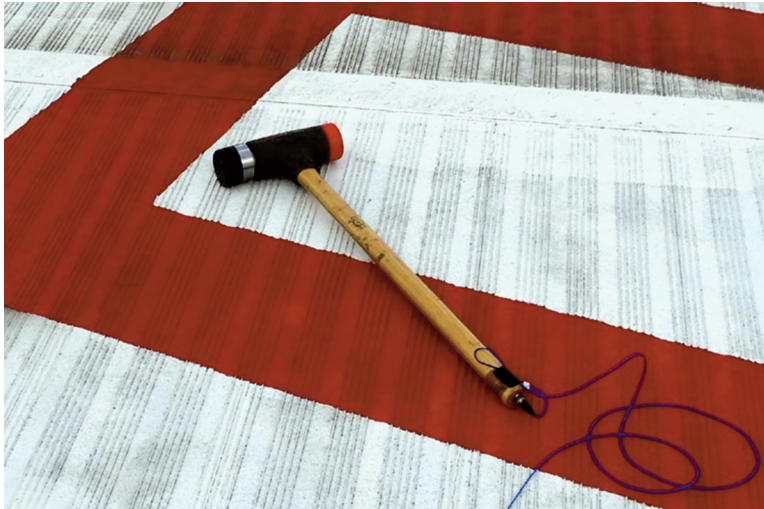
Fig. 3. Modal hammer for impulse exciting of large structures in the center of the helipad.

The study was conducted using the signal analysis of sensors located on the helipad structure in the range of up to approx. 150 Hz. To determine the vibration properties of the helipad a hammer was used as a vibration exciter (weighing 5.6 kg - Fig. 3.), acceleration sensors and multichannel measuring system with software to record and analyze response signals.

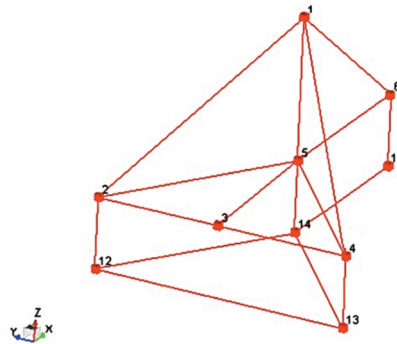
Fig. 5. Model for visualizing and evaluating the vibrations transferred to the building.

The tests for assessing the transferability of vibrations from the landing plate to the floors of the lower storeys of the building were carried out with the use of sensors measuring vibrations in the vertical direction which were placed: in the middle of the landing plate and on the lower storeys of the building. An example of the model used to visualize the vibrations of a concrete helipad is illustrated in Fig. 5.

The sensors' configuration included measurements of only vertical vibrations: at the landing plate center (sensor No. 1) and on the floor of the lower storey (in the vertical axis of the landing plate and adjacent rooms).

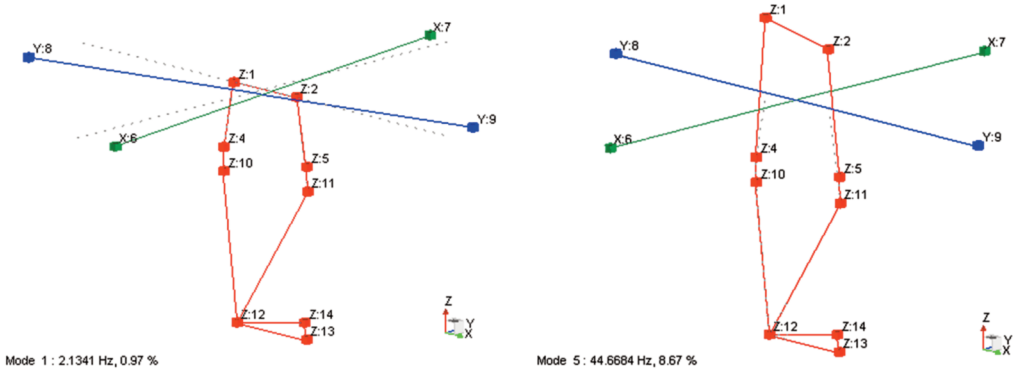
Fig. 6. Examples of measured vibrations shape of the helipad S1.

Table 1. presents the results of the basic vibration shapes, which occurred on all of the test helipads in similar form. The table contains: a description of the shapes, frequency of vibration and relative damping factors α in the range up to 100 Hz. Fig. 6. illustrates two examples of measured vibration shapes.

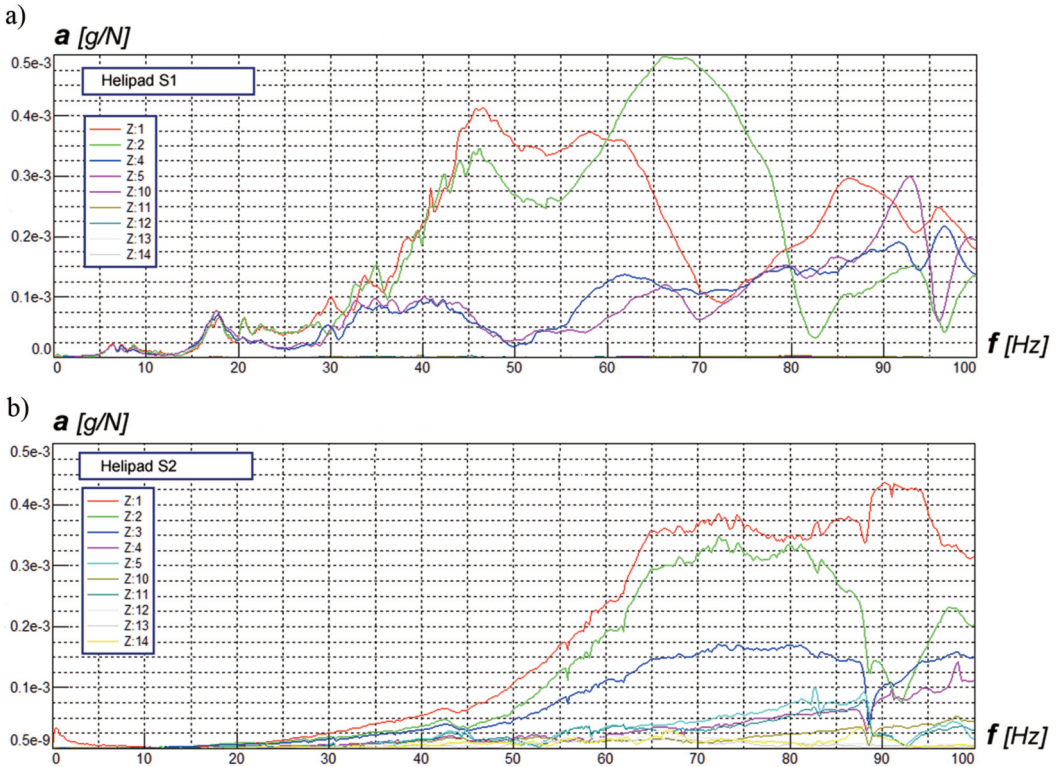
Fig. 7. Amplitude characteristics from sensors located in the middle of the landing plate and lower storeys, a – helipad S1, b – helipad S2.

and with the courtesy of the hospital management - in rooms almost ready for use. In all of these cases the helipads were completed. The sensors were placed on the floors indoors under the helipad and on the two highest storeys of the building in the vertical axis of the helipad and in the middle of the adjacent rooms. For steel-based helipads the distribution of sensors was assumed as in Fig. 4a. The amplitude-frequency characteristics obtained from the recording of the sensor signals received after the pulse excitation (caused by the use of the modal hammer) in the middle of the landing plate are presented in Fig. 7. Each characteristic is the averaged measurement result for five hammer impacts at the same point. The graphs are shown in unit [g/N] which enables to compare the results for hammer impacts with various force.

Basing on the graphs in Figure 7a. it can be concluded that due to the use of vibroinsulators in the pillar bases of the helipad S1, the vibration level recorded by sensors No. 10 - 14 is very small.

In the case of the helipad S2 (Fig. 7b), a small part of the vibrations is transferred from the landing plate to the lower storeys where they are subsequently suppressed and do not show individual resonances. Sensor No. 3 was located on the beam between the pillars with sensors No. 1 and 2.

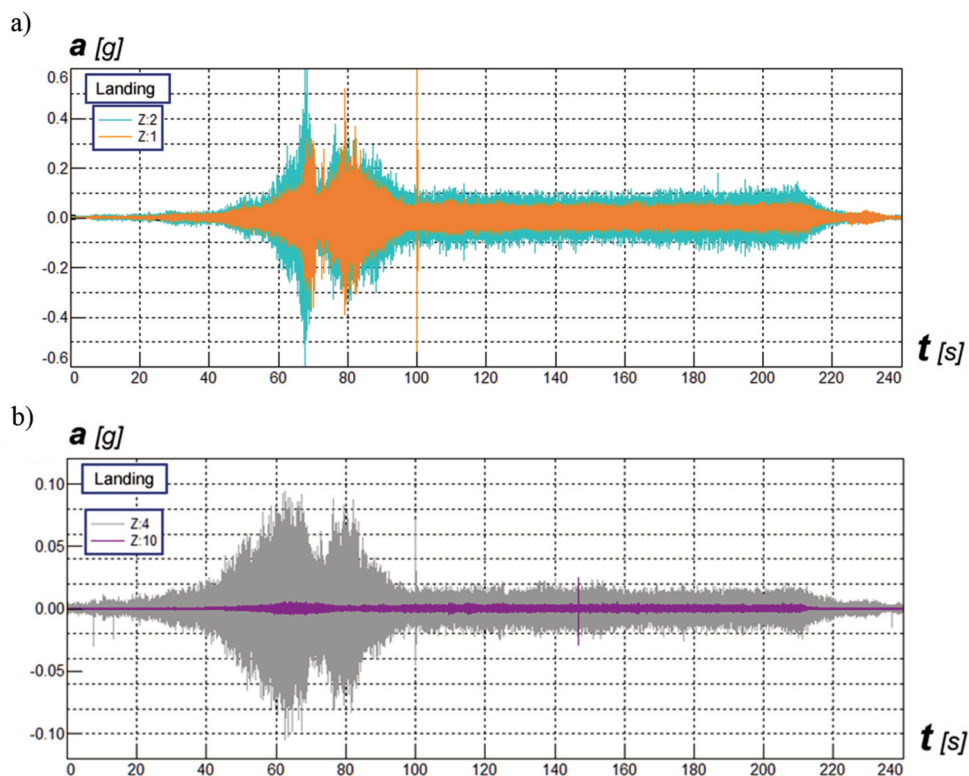
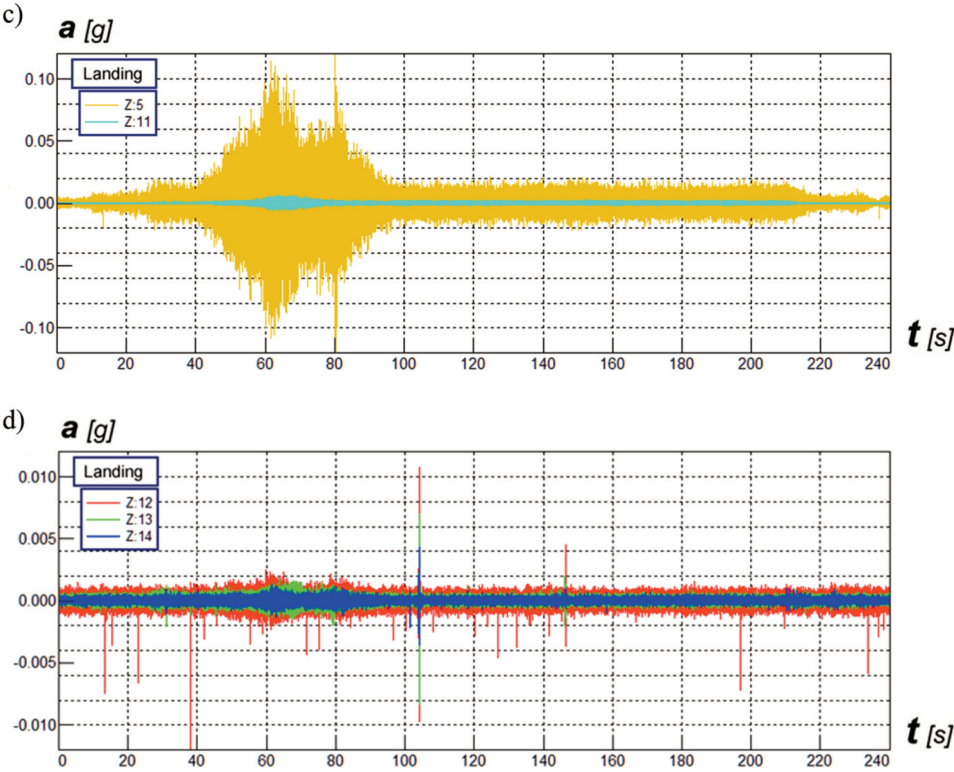
Fig. 8. Sensor signals diagrams during a helicopter landing on the helipad S1 (a-b).

Fig. 8. Sensor signals diagrams during a helicopter landing on the helipad S1 (c-d).

Figure 8 shows graphs of signals received from sensors during a helicopter landing on the helipad S1 and covers the time from the helicopter's approach to the helipad to the rotor stop. The stroke of the helicopter's skids over the landing plate occurred in 78. second of the recorded signal.

The graphs in Figure 8b and c represent the difference between the signals recorded on both sides of the vibroinsulator at the base of the central columns. The signal waveforms show decrease about 10 times in vibration levels, which indicates the effectiveness of vibroinsulators. The level of recorded vibrations on the lower floor (Fig. 8d) is approx. 0.01 m/s² (0.001g). The individual ‘peaks’ of the signal were of acoustic origin, because the recorded signal was sampled at a frequency of approx. 25600 samples/sec.
